The Annual Playground Inspection took place in March and we have received the report (this is an item later on the agenda)

Certified Inspection Report for: Swanscombe & Greenhithe Town Council Council Offices, The Grove Swanscombe Kent DA10 0GA		CONTACT :- Graham Blew / Dan (Head Groundsman) Tel: 01322 385 513 / 07736 255 774 E-mail: graham.blew@swanscombeandgreenhithe town council.gov.uk		ORDER NO :- 331357	SITE ADDRESS :- Manor Park St Peters Close, Swanscombe, DA10 0BU		SHEET 2 of 2
DESCRIPTION OF PRODUCT(S) INSPECTED	MAKER & YEAR	RISK RATING	INSPECTION COMMENTS	QTY.	PRODUCT CODE	DESCRIPTION OF PART(S) REQUIRED	UNIT PRICE
Litter Bin on Grass		L	Generally satisfactory but monitor wear at the timber cladding slats				TOTAL
Fence			Satisfactory condition				
Single Gate			Satisfactory condition				
Signage			Satisfactory condition				
Vehicle Access Gate			Satisfactory condition, looked at time of inspection				
Chain Link Gate			Satisfactory condition, looked at time of inspection				
General		M	Recommend regular grounds maintenance at the grass areas to combat erosion & reduce potential slip and trip hazards, especially at surface edging

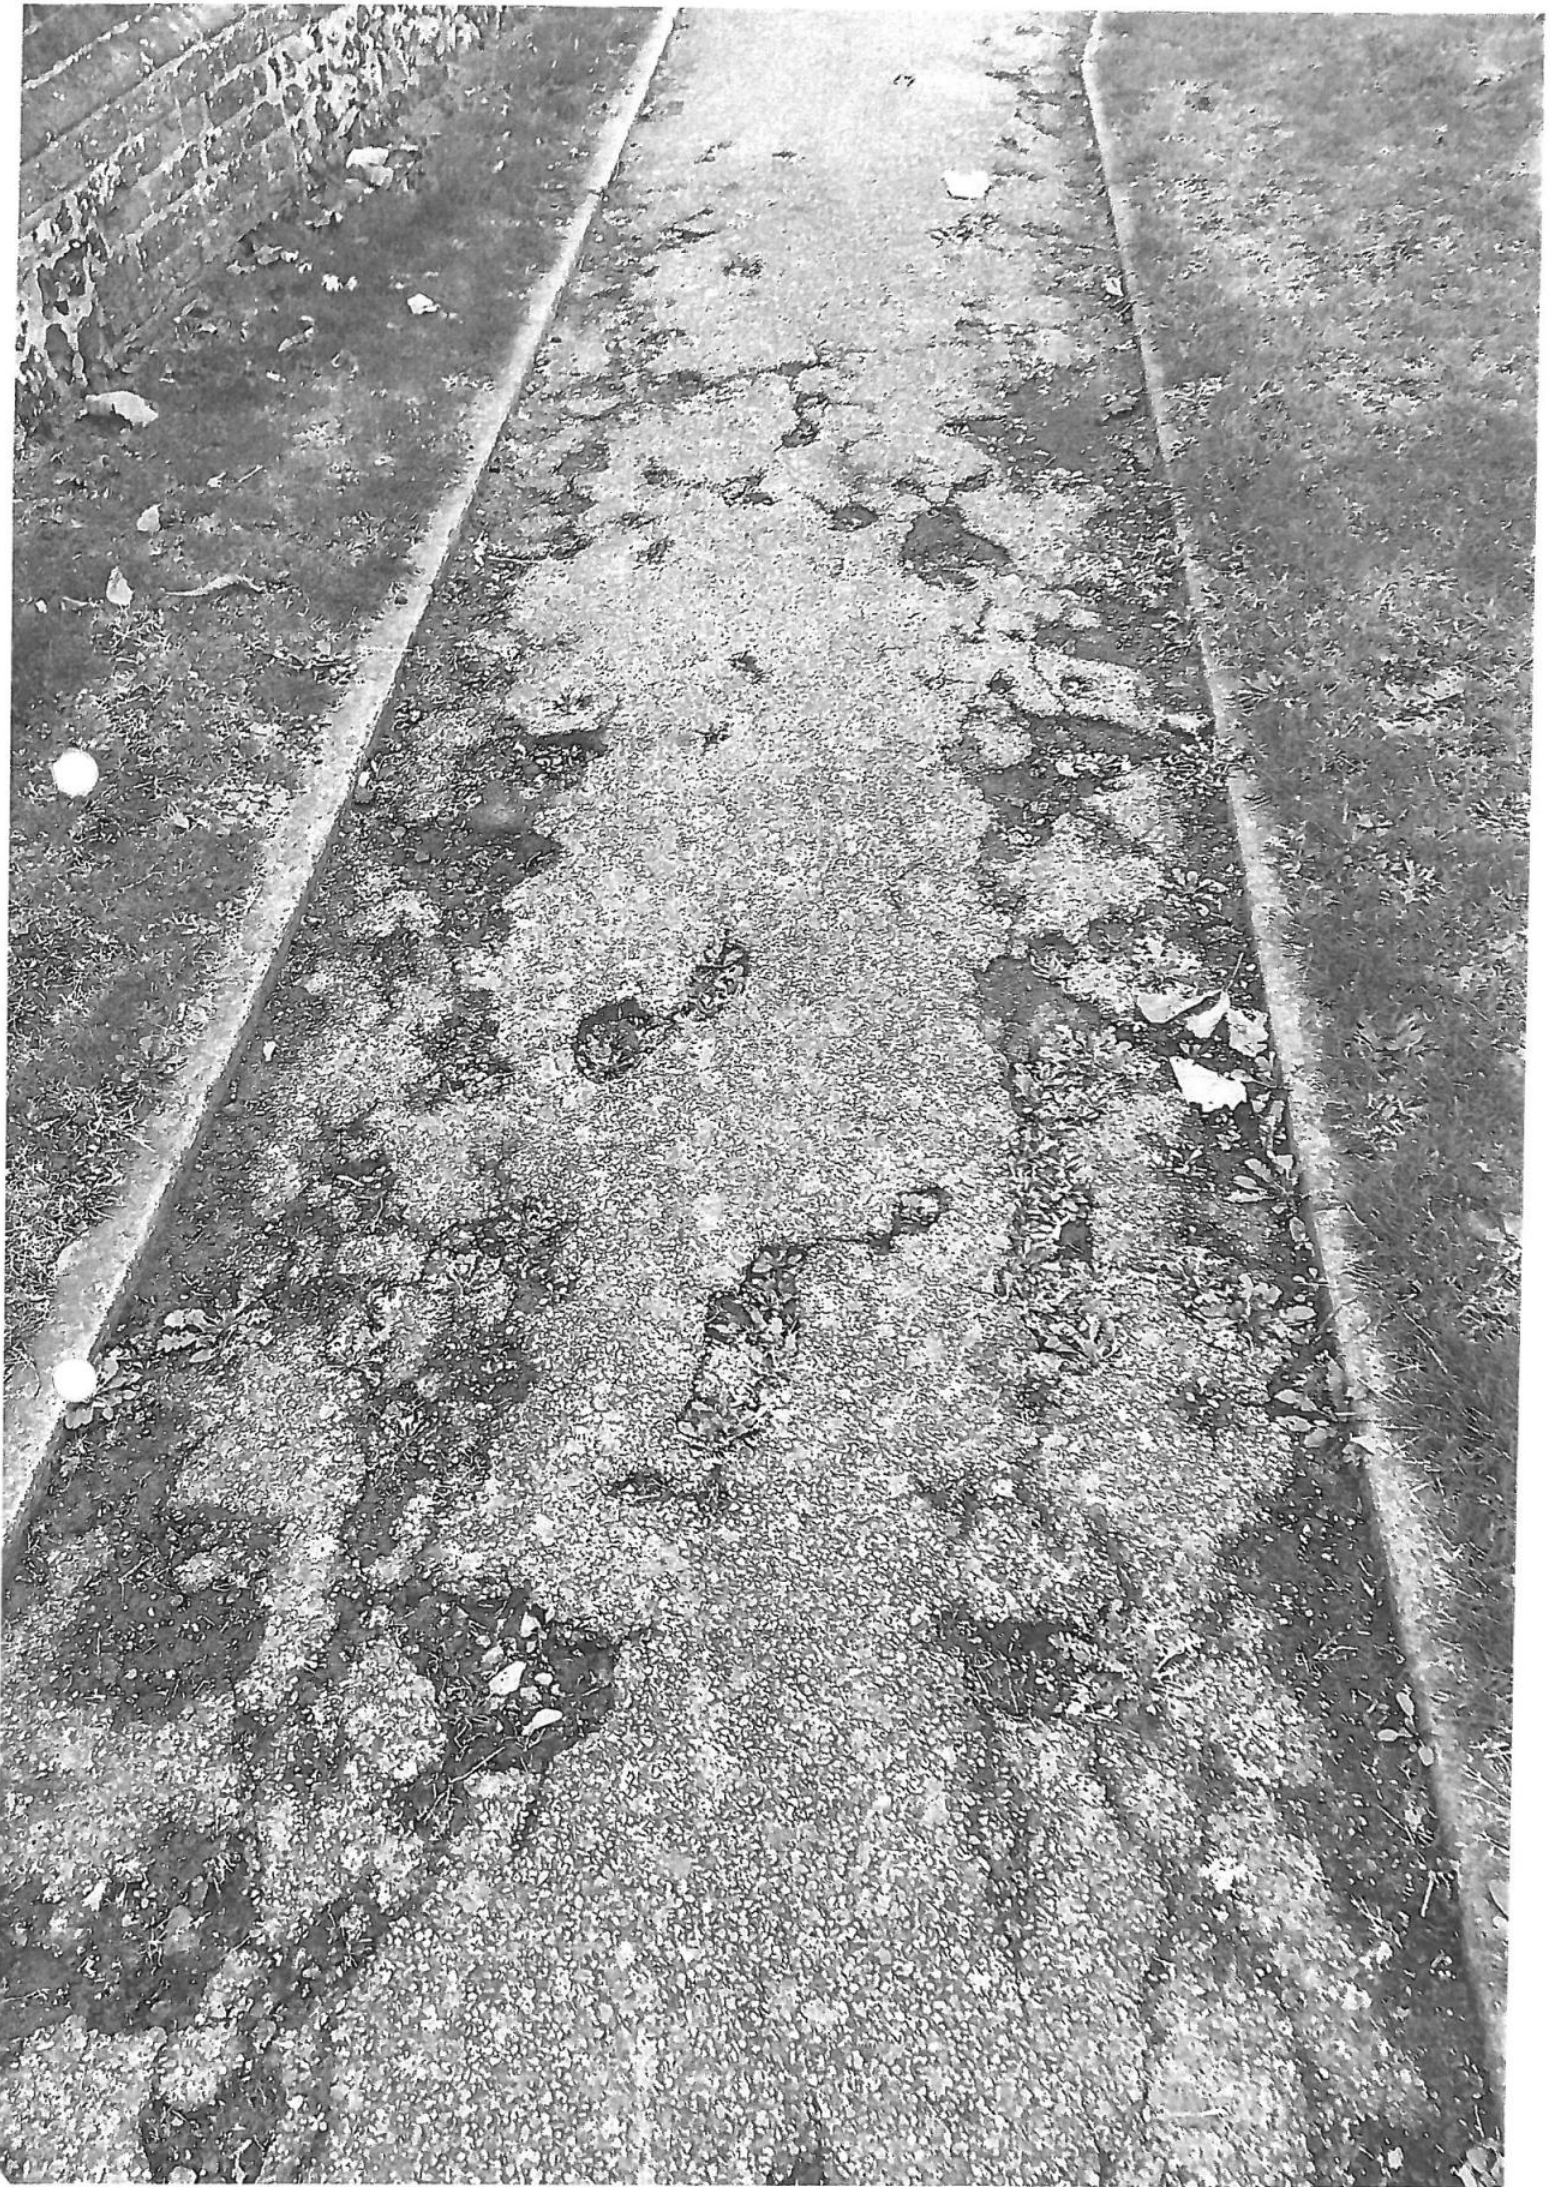
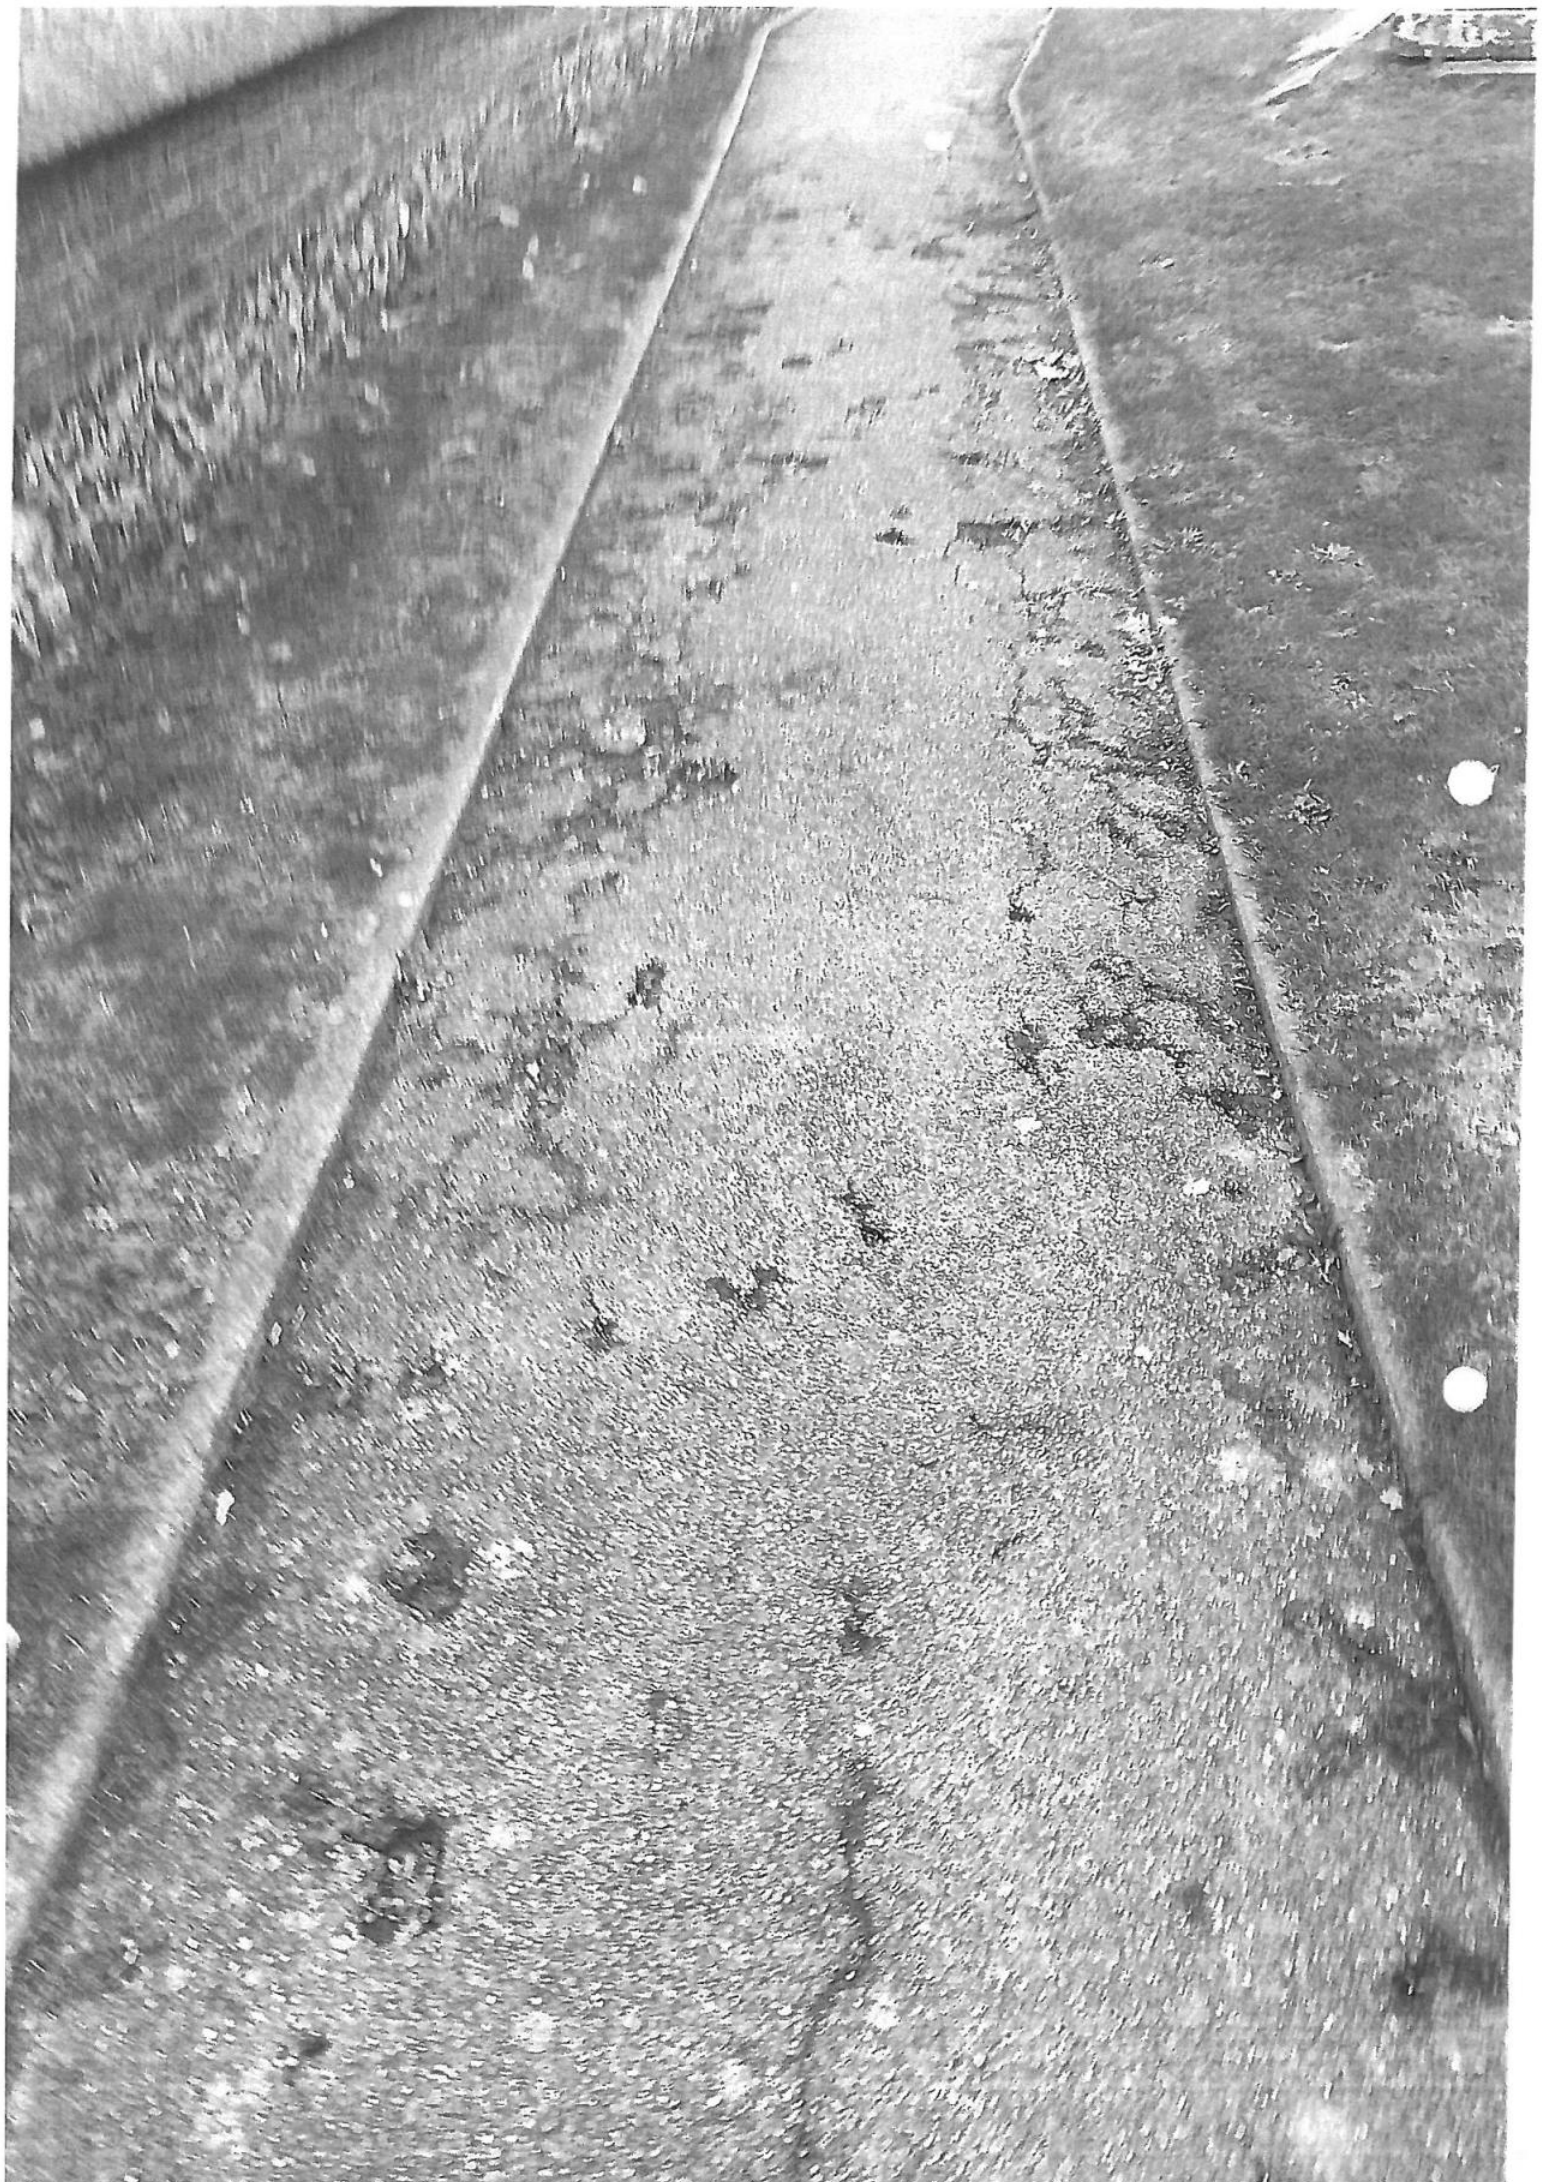
7.4 ST PETER & ST PAULS CHURCH FOOTPATH (SIDE ENTRANCE) (p).

Further to minute 169/16-17 the repairs to the slate footpath at the front of the Church were undertaken. Whilst this was being completed quotations were sought to repair the tarmac path leading through the churchyard (disabled access) and the attached pictures illustrate the condition of this footpath.

Quote:	Specification:	Price:
A	Option 1: Overlay to existing surface across 46m2	£2,000 + VAT
	Option 2: Dig out existing pathway and relay to include a wearing course across 46m2	£4,200 + VAT
B	Excavate degraded areas as required and relay a complete new wearing course across 65m2	£2,830 + VAT
C	Excavate degraded areas and relay 53m2 of wearing course and base. Overlay an additional 13m2 of wearing course and redress all other areas for a total area of 70m2	£2,753 + VAT
