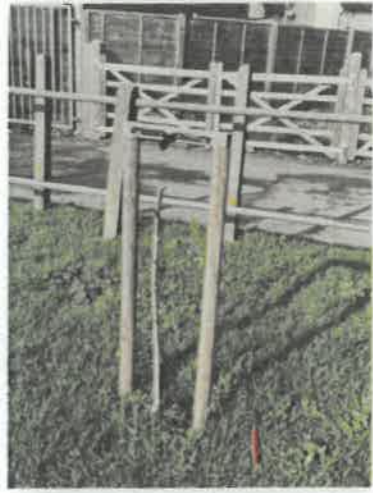
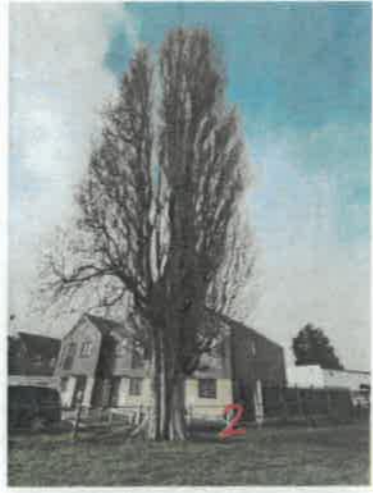
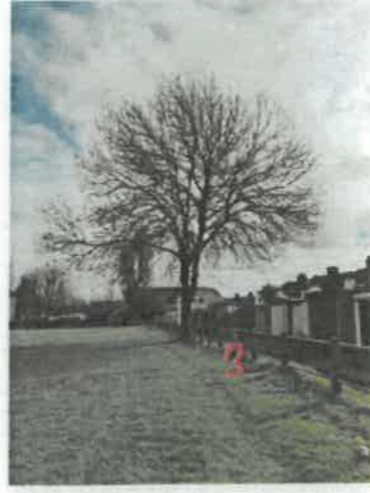
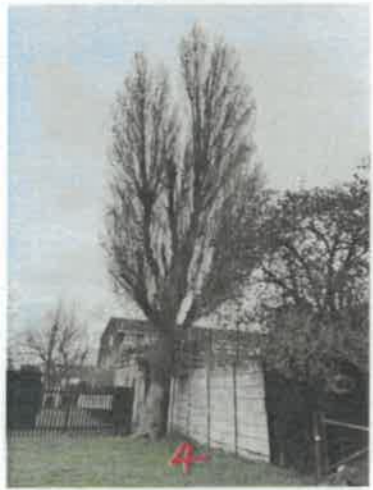
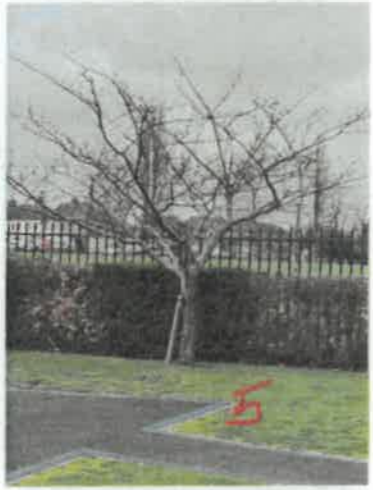
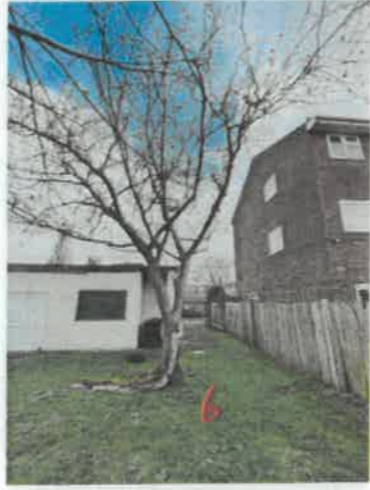
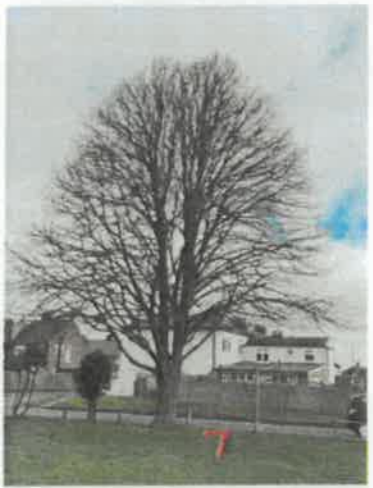
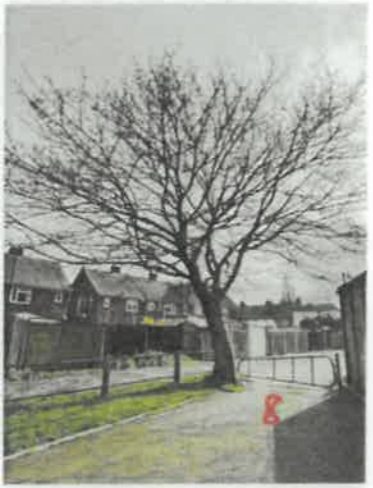
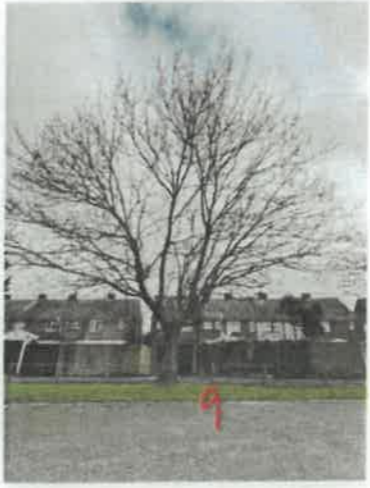
Site Pictures

Tree no	Species	Comment	Recommendations	Priority months
1	Dead new tree	Snapped off and dead	Replant	Advisory
2	Lombardy Poplar	Significant dead, particularly in the centre of the crown and at various other places in the crown	Remove the significant deadwood	3
3	Ash	A large tree with excellent shape very good condition. The lowest branch and several other branches do have an issue with over extension which puts them towards the limit. They have a habit of breaking in adverse weather when potentially over extended.	None at present.	na
4	Poplar	Large mature tree reduced some years ago due to potential decay at the base. Particularly on the side towards the railings is an area that sounds hollow when tapped with the sounding hammer on the east side of the base up to approximately 2 m. A large branch on the north side appears dead. The regrowth on the remainder is vigorous. Significant deadwood is present throughout.	Reduce the crown to the vicinity of the previous reduction to maintain a more stable tree and remove the significant deadwood and the large dead branch	3

5	Cherry	The stake is now redundant with the ties being too tight.	Remove stake	Advisory
6	Cherry	Cherry trees, declining, with loss of bark on the trunk and main lateral roots. The tree has a limited life span. (Note: No paint spot)	Reduce the crown by approx. 2m all over. Remove any deadwood.	3
7	Lime	Lodged small, broken dead branch right near the top of the crown. It's of relatively low importance and is unlikely to be a hazard to anyone.	Have a climber retrieve the broken branch and make an assessment as to whether it is a symptom of something more serious.	Advisory
8	Field Maple	Some significant deadwood in the lower crown and smaller deadwood over the driveway	Remove any significant deadwood	3
9	Field Maple	Some significant Deadwood in the crown, particularly the centre near the top. The tree had some major storm damage some years ago and had to have the centre of the crown removed.	Remove any significant deadwood	3

Tree no	Species	Comment	Recommendations	Priority months
10	Field Maple	Tree by the footpath leading towards the children's playground. Tree has a good scattering of minor and significant deadwood and some large stubs probably caused by unauthorised branch removal towards the rear garden adjacent.	Remove significant and tidy or remove any stubs	3
11	Poplar	The tree is located by the corner of the children's playground. Large quantities of significant deadwood throughout the crown	Remove the significant deadwood	3
12	Poplar	Some significant deadwood in the centre of the crown originating at approximately 8 m and above	Remove the significant deadwood	3
13	Poplar	Evidence of a scar on the south west side of the trunk up to approximately 2 m. Below 1 m there is evidence of some slime flux. Tapping the trunk with the sounding hammer gives no indication of any significant hollow.	No action at present	na

14	Lombardy Poplar	Two branches on the playground side have failed and also lodged across tree number 13. Some significant Deadwood is scattered throughout the crown.	Remove the two hung up branches and the remains of the stub and assess if there is a problem connected with the break, unable to be seen from the ground and report to the client or myself.	3
15	Poplar	Some scattered small deadwood sections and a few pieces of significant deadwood scattered throughout the crown. A few small dead branches are lodged in the crown are unlikely to represent a significant hazard. The tree has exposed main roots with the tops damaged by mowers. Round the base. There are many holes from the bee moth <i>Sesia apiformis</i> that can indicate a reduced vitality.	Remove the deadwood and hung up small branches.	3
16	Goat, Willow	The tree is adjacent to the garden fence. Many branches have been cut off on the fence side and dumped alongside the fence, making it inaccessible. The tree is heavily clad in ivy up to approximately 5 m.	Sever the ivy to allow future inspections.	Advisory

Tree no	Species	Comment	Recommendations	Priority months
18	Lombardy Poplar	Some significant deadwood scattered throughout the crown.	Remove the significant deadwood	3
19	Lombardy Poplar	Some significant deadwood scattered throughout the crown	Remove the significant deadwood	3
20	Lombardy Poplar	Some significant deadwood scattered throughout the crown	Remove the significant deadwood	3
21	New dead tree	Snapped off and dead	Replant	Advisory
22	Poplar	A small amount of significant deadwood in the upper crown area and a small lodged branch. Areas of potential decline at approximately 2 m, with dysfunctional bark. At the base, holes from the bee moth indicating a longer term potential decline. The base of tree returns a good sound with sounding hammer.	Remove the significant deadwood	3
23	Poplar	Some significant deadwood scattered throughout the crown.	Remove the significant deadwood	3
24	Lombardy Poplar	Some significant deadwood throughout the crown	Remove the significant deadwood	3

25	Poplar	Some significant deadwood throughout the crown and a large lodged branch.	Remove significant deadwood and the lodged branch.	3
Note	Poplars in general alongside the paths.	<p>Where tree toots are under the tarmac paths, there will be cracks and a slight raised surface.</p> <p>Generally, I would suggest that you remove the tarmac, back a metre or so if necessary, clear carefully around the root and put sand around it and over to a depth of 25mm or so. Note that it must be horticultural sand as the salts in building sand can damage the root. Then you may wish to gently ramp the tarmac on the approach to the root and then lay the tarmac over the root. It is unfortunate that the root will continue to expand and that this is only a temporary measure.</p> <p>If required, to avoid there being a difference in height between the tarmac path and the grass, it can often be raised up to the same level, as a gentle rise (spreading it out to aid the mower and also prevent a trip hazard. Relay turf to finish the repair.</p>		Advisory

Tree no	Species	Comment	Recommendations	Priority months
27	Scots Pine	Somebody has attached birdfeeders to the tree trunk with metal jubilee clips and plastic electricians ties. The metal Jubilee eclipse are already beginning to cause damage to the trunk in the form of construction, preventing the trunk from expanding due to annual growth.	Remove the birdfeeders attached with Jubilee clips and ties around the trunk. It may be appropriate to tape a note to the tree saying that any further attachments will be removed.	3
28	Cherry	Young tree that no longer needs its stakes. One stake has already rotted at the base.	Remove the tree stakes	Advisory

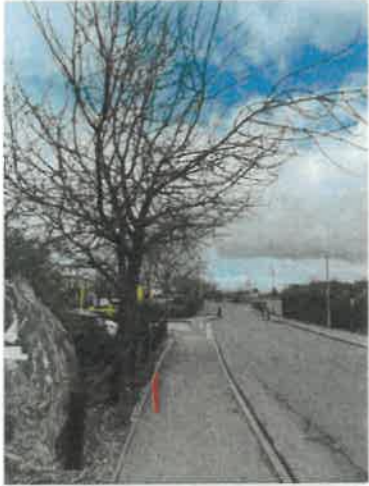
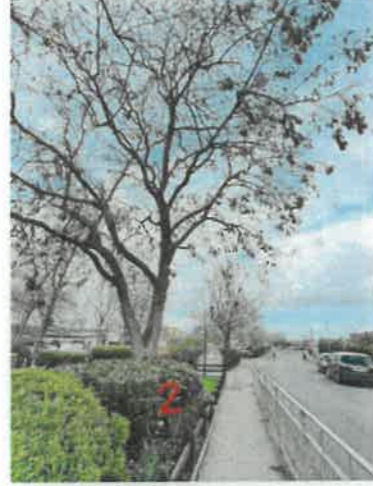
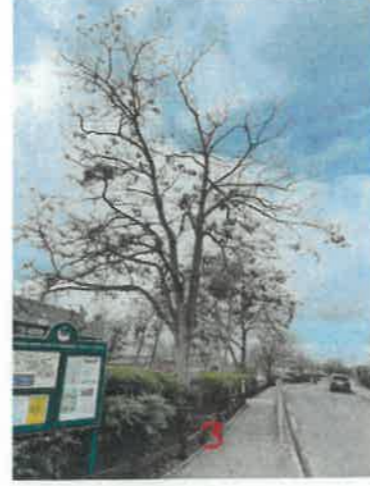
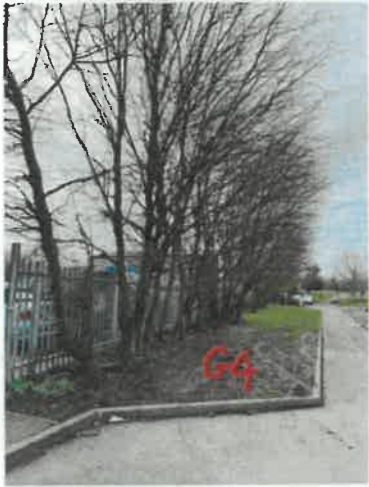
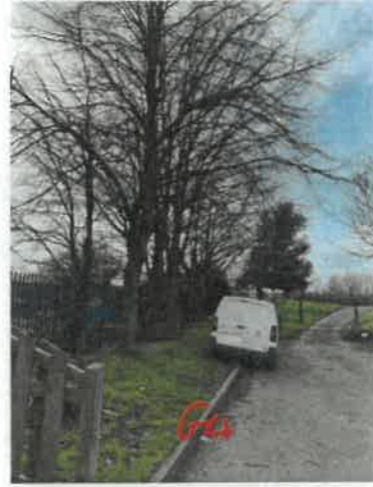
Site Pictures

Tree no	Species	Comment	Recommendations	Priority months
1	Cherry	Tree is generally in good condition, but has a low crown over the highway.	Raise the crown over the highway to approx. 5m	3
2	Robinia	Small amount of deadwood over the pavement as well as in the rest of the tree.	Remove any significant deadwood that might affect the pavement	3
3	Robinia	Scattered deadwood including some significant deadwood throughout the crown, plus one broken branch at about 5 m.	Remove the broken branch and any significant deadwood	3
G4	Mainly Hornbeam group	A large section of G4 is protected by Tree Preservation Order. Cars are driving and parking under the tree canopies on the grassy area normally described as the Root Protection Area. This will over time cause serious compaction and be detrimental to the health of the trees.	Recommendation is to put some form of barrier to prevent cars from parking on the grass.	Advisory

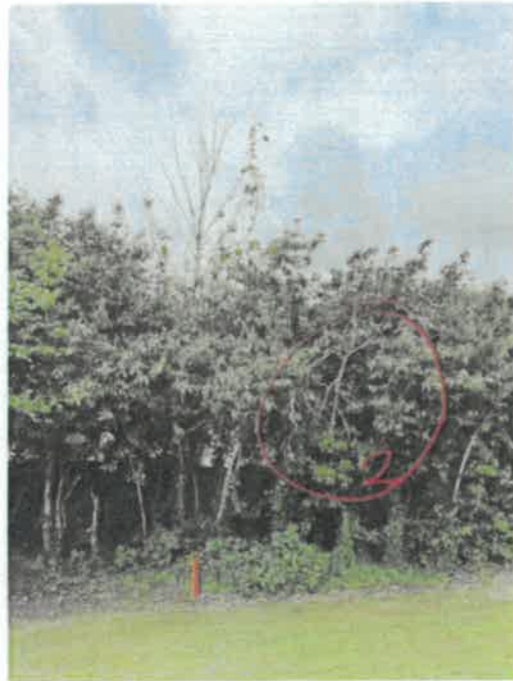
Site Pictures

Tree no	Species	Comment	Recommendations	Priority months
1	Sycamore	Semi mature Sycamore at the back of the shrub border close to the corner of the next door house the tree is in serious decline. The top of the tree is dead.	Fell Sycamore. Conservation Area permission will be required to fell the sycamore.	3
2	Portuguese Laurel	A number of stems on the front face are dead, some have already been cut back recently.	Remove the dead stems (No Conservation Area permission required as they are shrubs and small diameter stems)	3

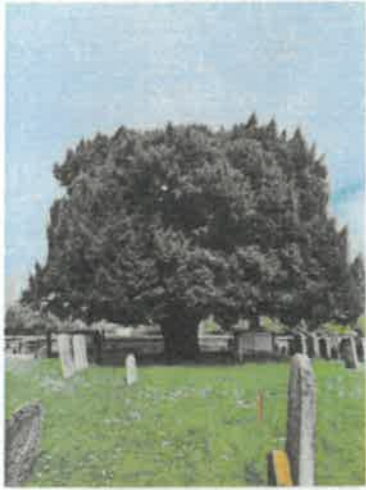
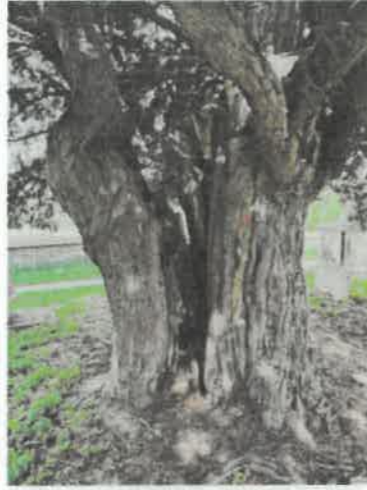
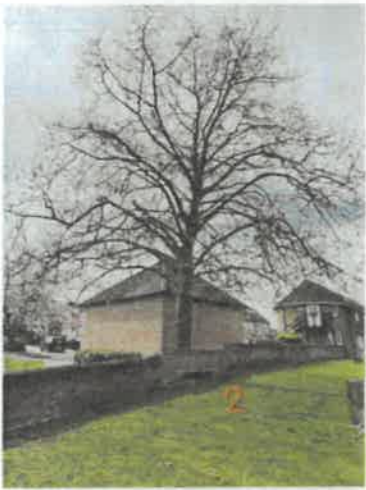
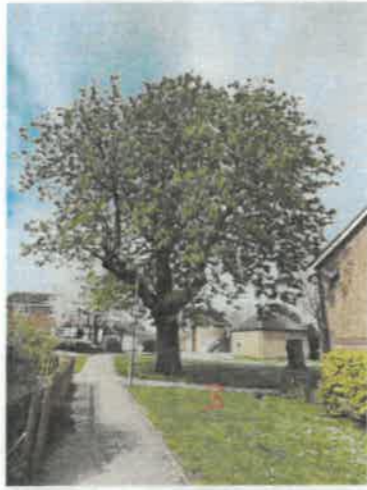
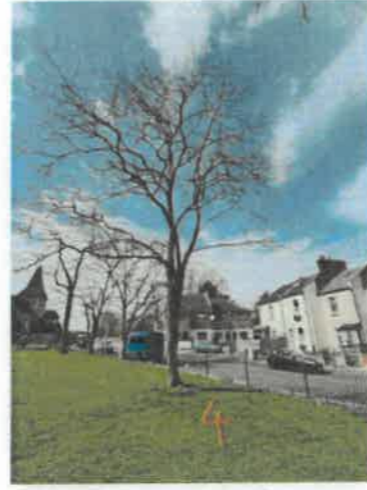
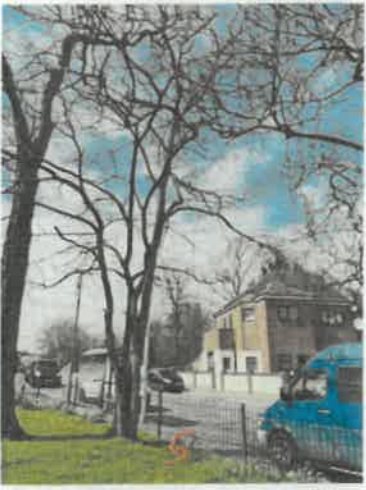
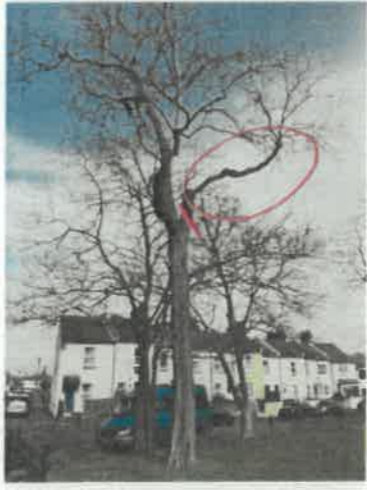
Site Pictures

Tree no	Species	Comment	Recommendations	Priority months
1	Yew	<p>A veteran tree in the churchyard, beautiful shape where is a measure of decay in the lower 2 1/2 m of the trunk. This decay is effectively separating the two parts of the tree with the side towards the church building effectively being the established main tree. The other third of the tree has historically separated a little from the remainder of the tree as shown by a split at approximately 1.5 m. At the present the tree is stable and does not present a problem.</p> <p>However as the tree continues to grow it will get heavier and potentially may pull apart.</p>	<p>Two options either singly or together are possible.</p> <p>1. A crown reduction of between 1 m and 2 m overall will reduce the tendency to pull apart.</p> <p>2. A cobra four tonne brace would also act to reduce the potential for failure, particularly in adverse weather.</p>	Advisory

Tree no	Species	Comment	Recommendations	Priority months
4	Robinia	The two stems are twin with a natural brace at approximately 4 m. Significant deadwood throughout the crown. TPO tree	Remove any significant deadwood Note, does not specifically require TPO permission but must be notified with a minimum of 5 days notice.	3
5	Robinia	Triple stem tree closely intertwined. Some significant deadwood throughout the canopy. TPO tree	Remove any significant deadwood. Note, does not specifically require TPO permission but must be notified with a minimum of 5 days notice.	3
6	Robinia	A mature tree that has had large sections removed previously. A large section of deadwood is present, which in itself is not a significant problem. The stem that has been drastically reduced has one branch on it that is in poor condition with the top (tension side) lacking in the bark. The other main stem has some decline in the bark just below its crown. TPO tree	The works are recommended due to the potential for failure of the branch in an area that children play, Remove the damaged branch and the section of stem to the fork (as per the photo). TPO permission will be required	3

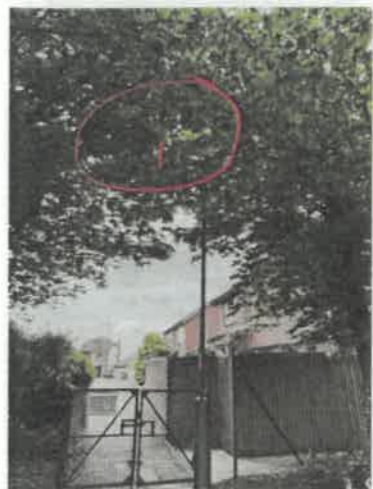
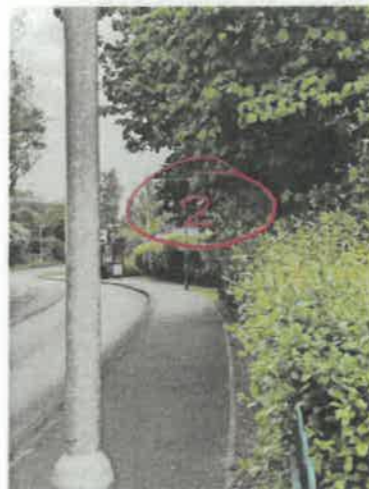
Site Pictures

Tree no	Species	Comment	Recommendations	Priority months
1	Hornbeam	A group of four trees, the tree nearest the gate (marked with a red spot) needs to have some small branches removed to clear the street light	Reduce the crown away from the street light	3
2	Hazel	Hazel clump in the corner has some low branches over the pavement.	Lift the crowns over the pavement to approximately 3 m.	3

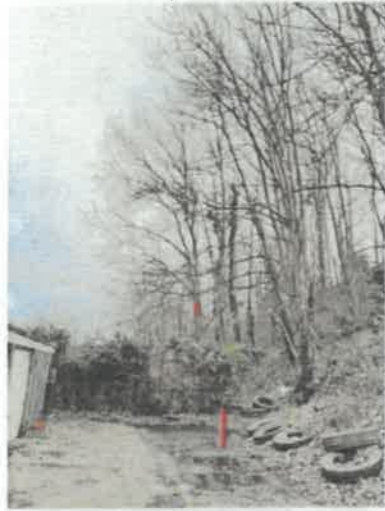
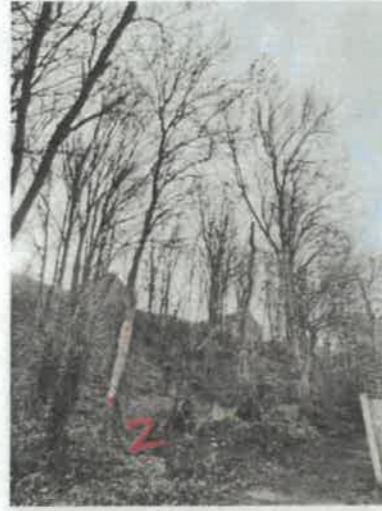
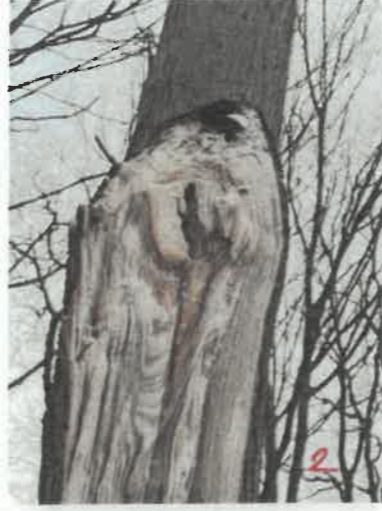
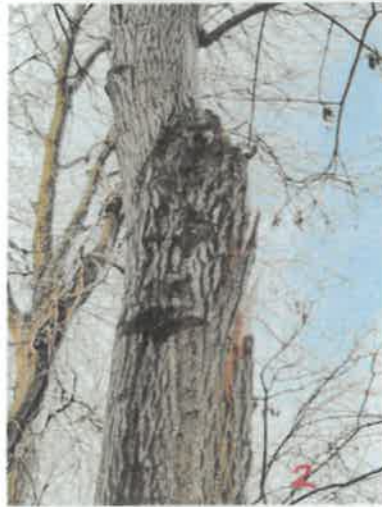
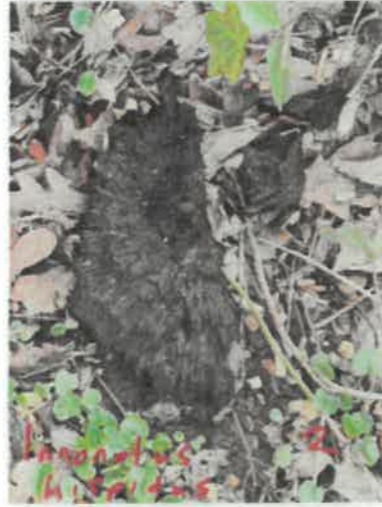
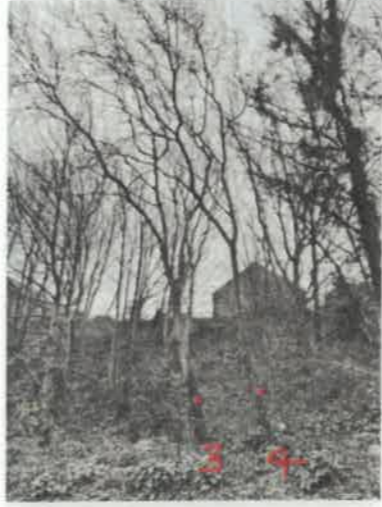
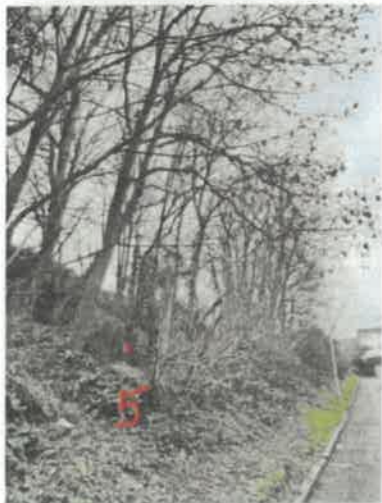
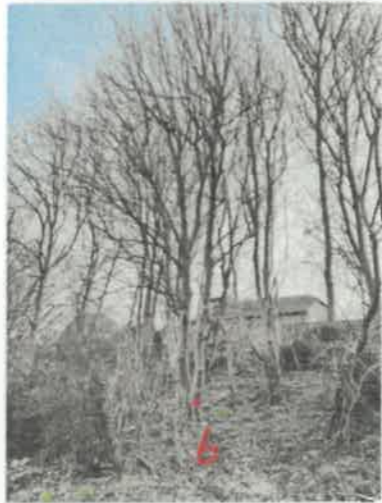
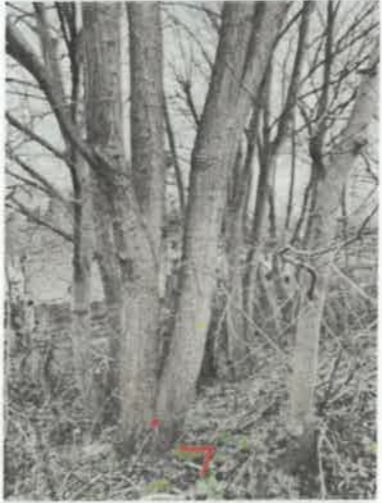
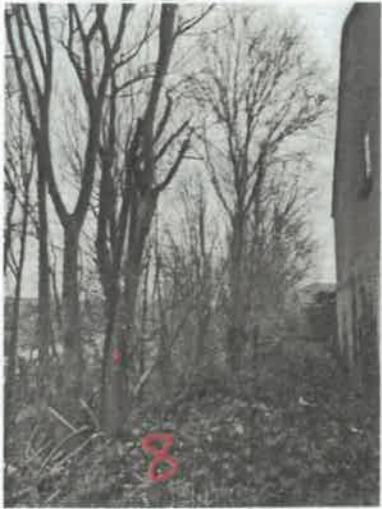
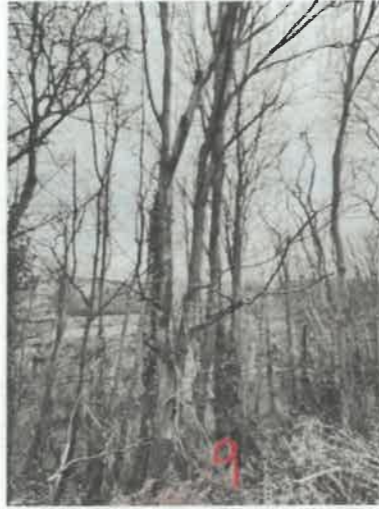
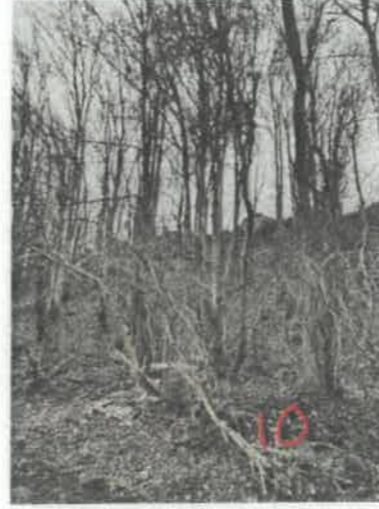
In the case of T2, a small broken branch in the fork allowed the establishment of a fungus that caused a weakness in the fork that in the case of an exceptional adverse weather was at greater probability of failure.

Tree no	Species	Comment	Recommendations	Priority months
1	Ash	Very large ash tree alongside the footpath overhanging the derelict building site, the large branches across the path all have dead undersides. The bark has all died off due to the fire some years ago. Significant deadwood (consisting of large dead branches) are located above the footpath. Resting against the tree is a fallen Ivy clad Ash, a small diameter tree that also overhangs the footpath.	Remove any significant deadwood. Reduce the branches with significant bark die back on the underside by approximately 50%. Fell to ground level. The small diameter Ash tree lodged against the trunk of tree number one.	3
2	Maple	Large Maple that originally had a fork at just above 3m. The fork failed during a recent storm leading to the stem hitting a garage nearby. Investigation of the tree has shown a shadow mark just below the fork left by Innonotus hispidus. The old fruiting body was found on the ground below the decay which affected the structural integrity of the fork, allowing the storm wind to split the fork.	Fell the remainder of the tree	ASAP

3	Ash	The lowest main branch is overextended towards the road and streetlight, and is likely to be at risk of failure. Some significant Deadwood is present throughout the crown, but as it is well into the woodland edge, it represents a low risk.	Reduce the large limb heading to the road by approximately 3 m to reduce the risk of failure. While the climate is in the tree, remove the significant Remove the significant deadwood as a matter of habit while climbing.	3
4	Ash	Ash tree adjacent to T3 also has a large limb over extended to the roadway.	Reduce the large limb heading to the road by approximately 3 m to reduce the risk of failure. While the climate is in the tree, remove the significant Remove the significant deadwood as a matter of habit while climbing.	3
5	Hawthorn	Small dead tree within almost falling range of the road	Fell	3

Tree no	Species	Comment	Recommendations	Priority months
6	Sycamore	Large twin stem tree close to the roadside. A crown reduction has been carried out in the past. Regrowth is plentiful but appears to be subject to squirrel damage (stripping the bark and causing death or breakages of the weakened stems). At the time of the inspection, at least two branches are broken and hanging near the roadway edge.	Climb check and remove the squirrel damaged branches and any broken or damaged branches. If the squirrel damage looks to be severe during the removal of the damaged branches, a prudent course of action will be to reduce the crown to the vicinity of the previous reduction.	ASAP 6
7	Wych Elm	A large tree growing near the top of the bank adjacent to the garage adjacent the end house. The tree is relatively fast growing and presents a tight included fork at the base of the main fork. The same formation of a tight fork is at approximately 3m. These tight forks with included bark are notoriously weak and may be subject to windblow. The crown is very tall and is now above the average tree line. Given the propensity for stronger winds, both weak forks are likely to fail, maybe towards the building.	The prudent option is to reduce the height of all three main stems by approximately 4 m to reduce the wind sail.	6

8	Sycamore	Trees by the gable end of the nearby house. One stem closest to the house has extensive bark loss, possibly due to canker at approximately 3m above ground level. The stem with the bark defect is at risk of failure.	Remove the stem damaged with canker	3
9	Sycamore	Relatively small dead stem from about 2m height. If it were to fail, there is the potential to possibly reach the fence	Remove the dead stem at the fork.	3
10	Sycamore	Large stem originating at approximately 2m on the side facing to the garages. The majority of the bark around the base has died and fallen off. The stem is likely to fail towards the garages.	Remove the affected stem	ASAP

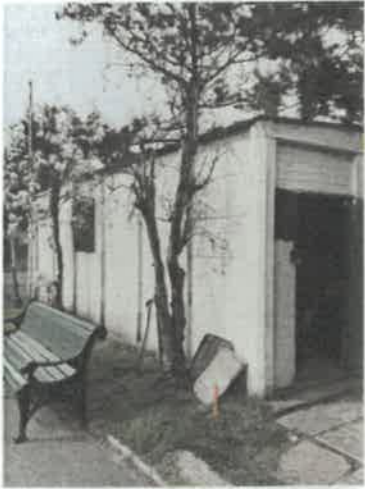
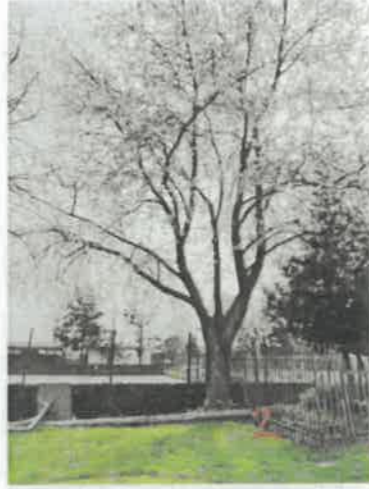
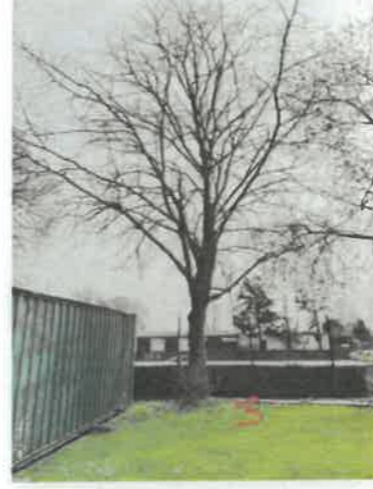
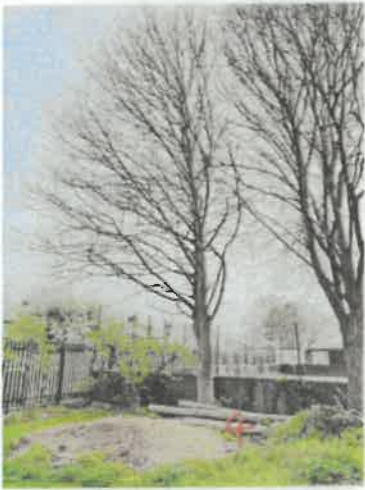
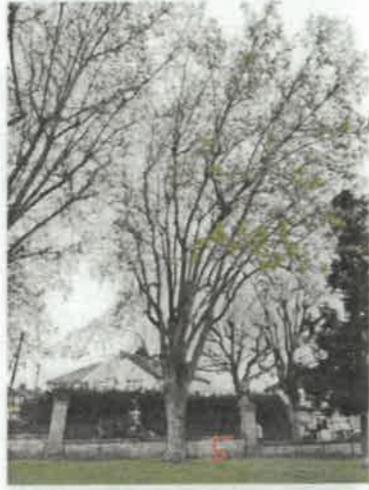
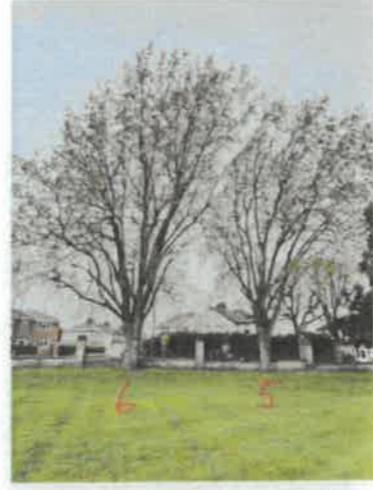
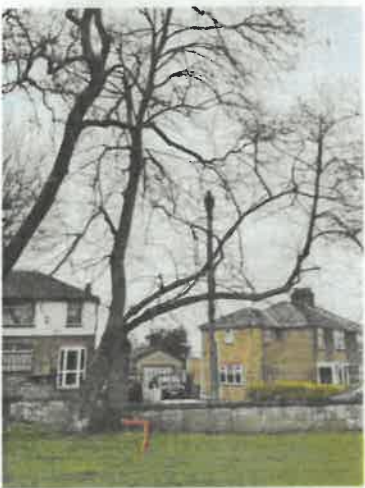
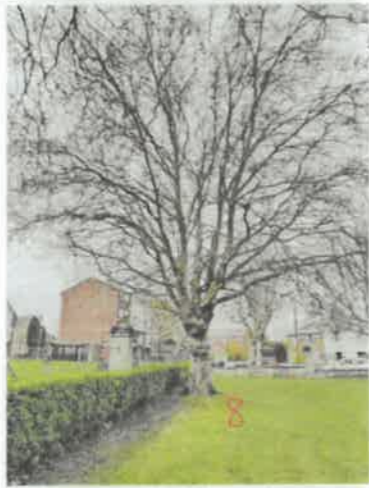
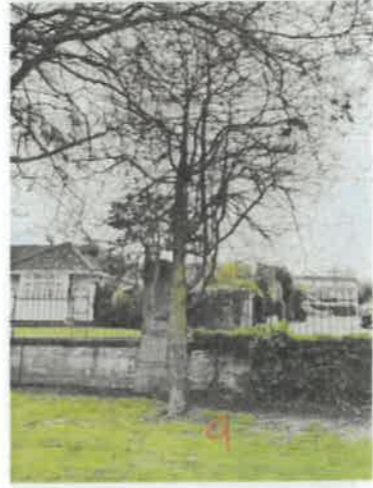
Tree no	Species	Comment	Recommendations	Priority months
9	Leylandii	Dead (apart from one small branch towards the fence pillar)	Fell	3
10	London Plane	Some significant deadwood, particularly on the site towards the footpath in the park	Remove the significant deadwood	3
11	Elderberry	Large mature elderberry along the cemetery boundary has a couple of large, dead stems and some smaller deadwood	Remove the large, dead stems	3
12	Silver Birch	Some significant deadwood in the lower crown above the seating area	Remove the dead branches	3
13	Silver Birch	One of a pair of trees, the top 2 m of the trunk is dead and at least one of the branches nearby is in poor condition with a lump of deadwood attached. Also a large small hanging branch.	Remove the dead top of trunk and poor condition branch. Remove the lodged branch.	3
14	Silver Birch	Mature tree with a cavity at approximately 3 m that is at present judged to be acceptable. Some significant deadwood is scattered throughout the crown, particularly on the stem above the cavity.	Remove any deadwood that may affect the children's area	3

15	Silver Birch	Some significant deadwood scattered throughout the crown and includes a large dead stub at about 5 m	Remove the large, dead, stub and significant deadwood	3

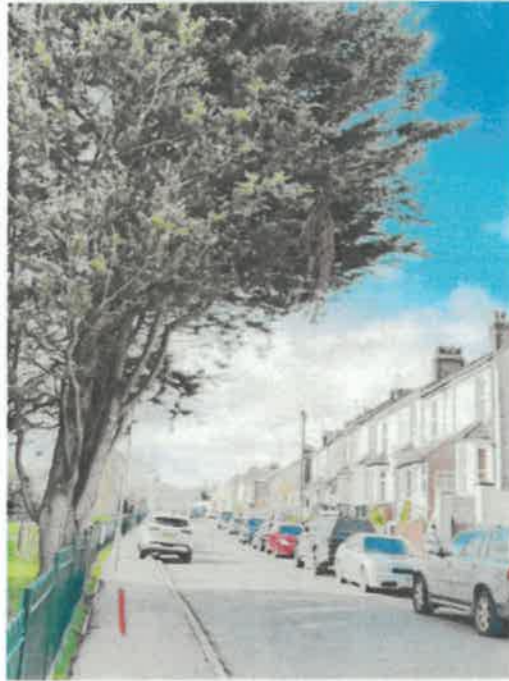
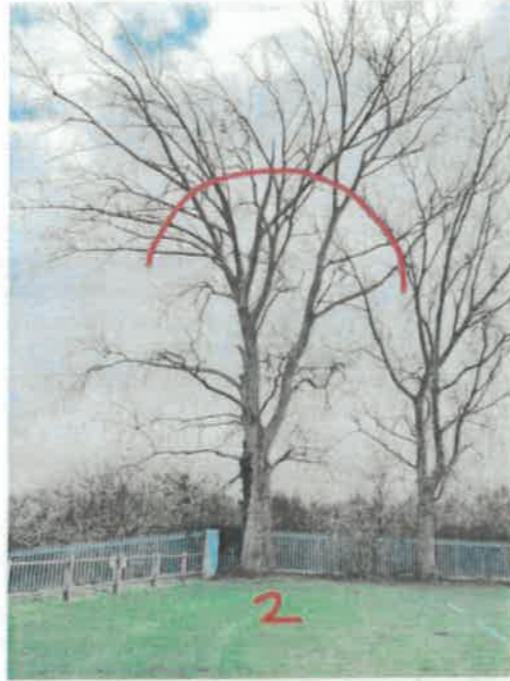
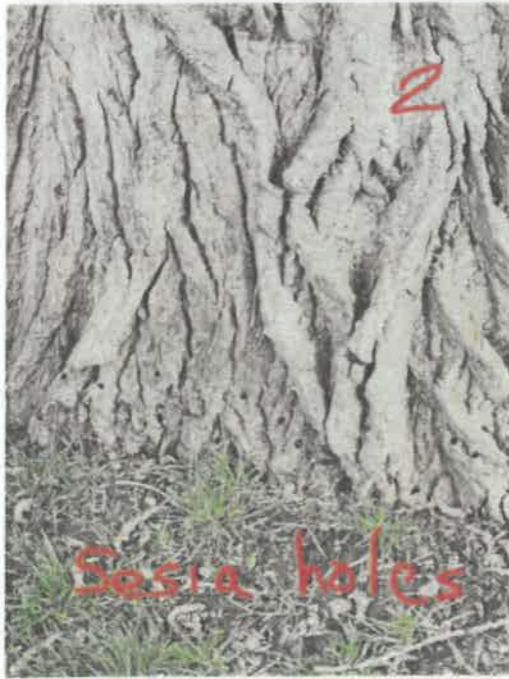
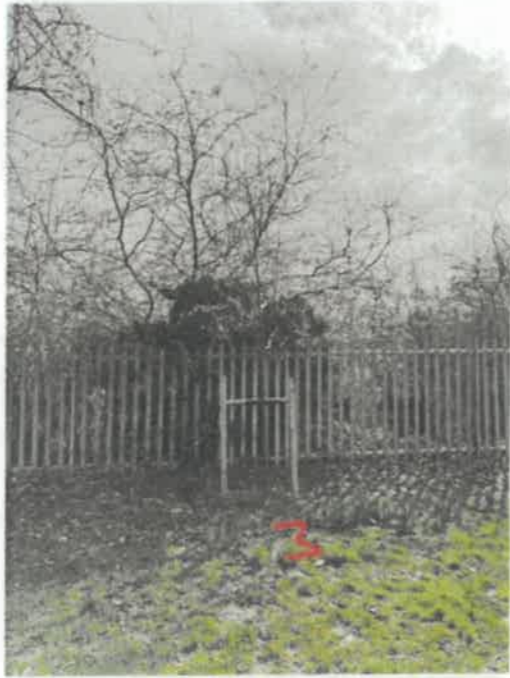
Site Pictures

3, 4, 5, 6	New planting	Dead	Replace in the late autumn planting season.	Advisory
7	Oak	Significant deadwood in the tree and particularly the stem overhanging the Recreation Ground, just where the dog walkers walk along the fence line.	Remove any significant deadwood that may affect the Recreation Ground.	3

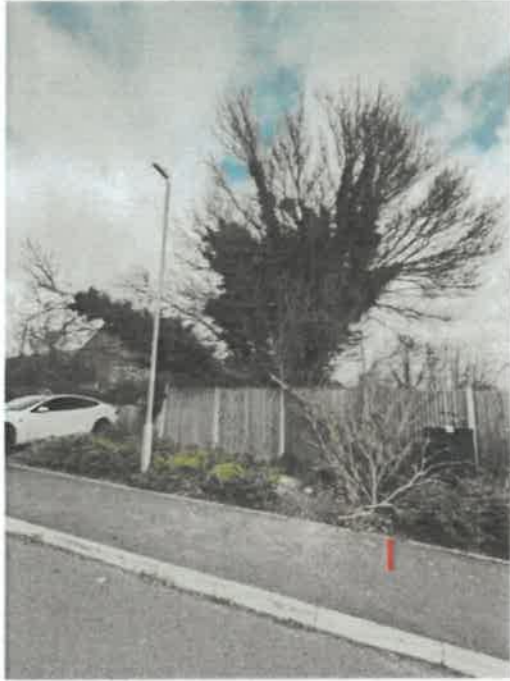
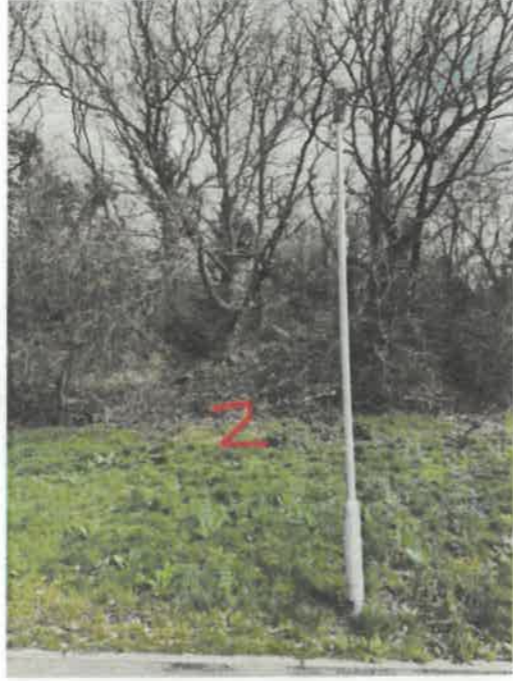
Site Pictures

Tree no	Species	Comment	Recommendations	Priority months
1	Field Maple	Not sure whether this tree belongs to Swanscombe or not field maple overhanging the fence towards the roadway, leaning branch with damage cloud with ivy, plus also a fallen branch that has been partially cut and stacked.	Remove the fallen branch and risings and cut back the overhanging, leaning branch to the boundary	3
2	Oak	Oak tree partly up the bank adjacent to an unofficial little path up to the top of the hill. It is believed the tree is within Swanscombe ownership. Branches are interfering with the Lamppost.	Reduce the crown away from the lamp post to give approximately 2 m clearance	3

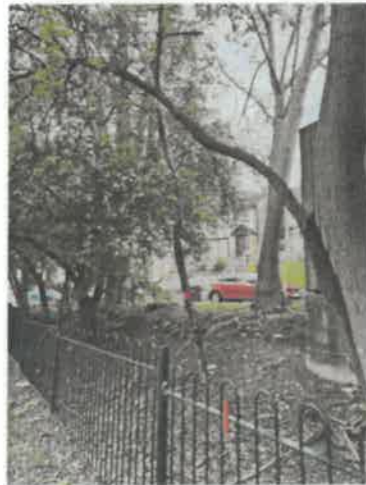
Site Pictures

Tree no	Species	Comment	Recommendations	Priority months
1	Small dead stem	Small dead stem possibly Hawthorn to the rear of the fenced substation area just outside the playground fence.	Fell	3
