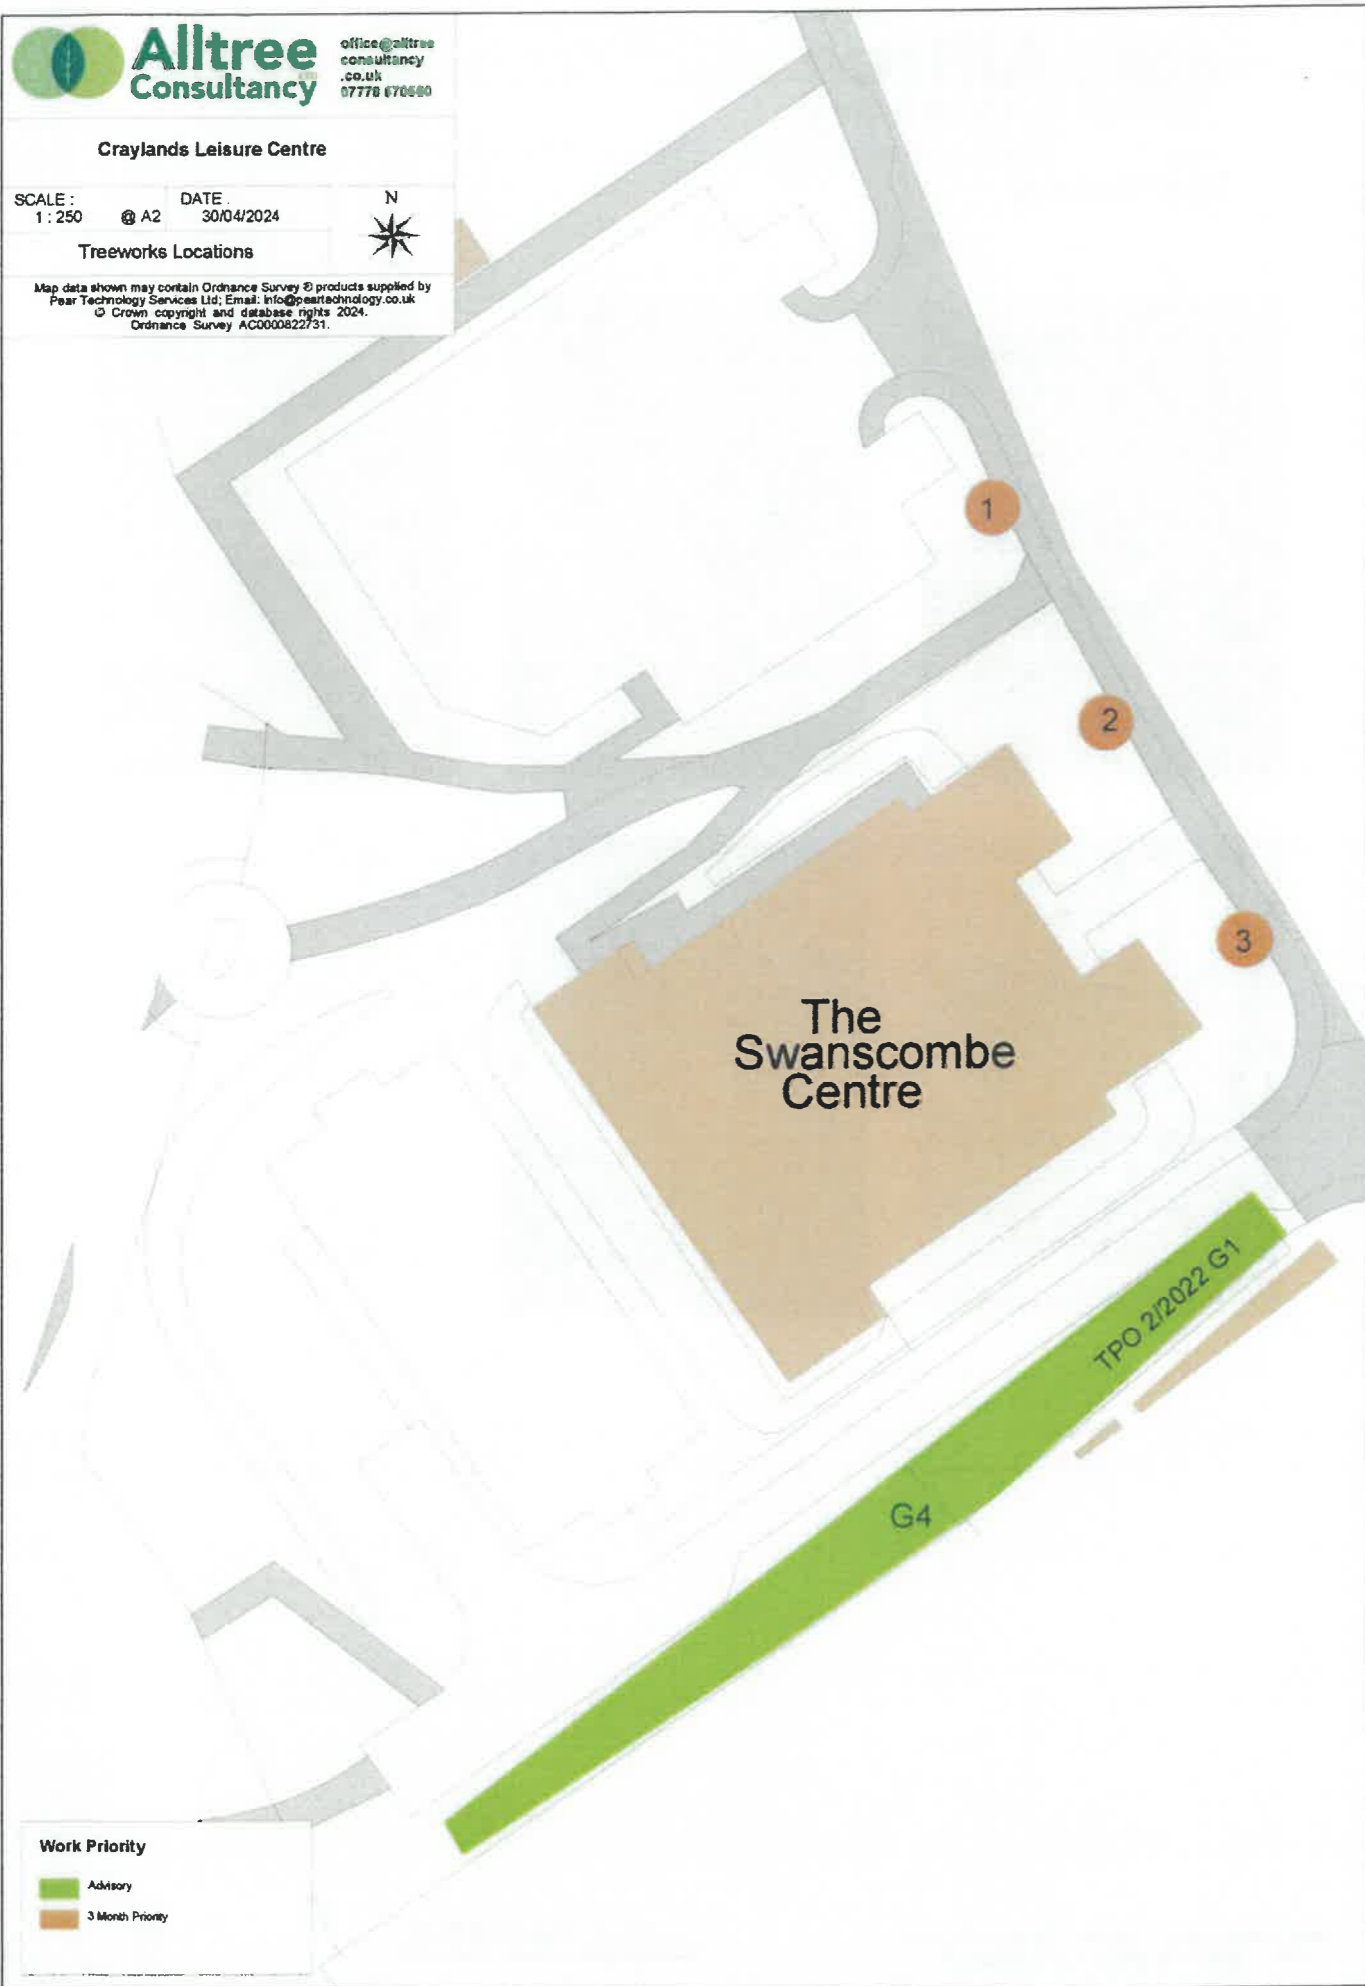
Treeworks Locations

Tree no	Species	Comment	Recommendations	Priority months
1	Cherry	Tree is generally in good condition, but has a low crown over the highway.	Raise the crown over the highway to approx. 5m	3
2	Robinia	Small amount of deadwood over the pavement as well as in the rest of the tree.	Remove any significant deadwood that might affect the pavement	3
3	Robinia	Scattered deadwood including some significant deadwood throughout the crown, plus one broken branch at about 5 m.	Remove the broken branch and any significant deadwood	3
G4	Mainly Hornbeam group	A large section of G4 is protected by Tree Preservation Order. Cars are driving and parking under the tree canopies on the grassy area normally described as the Root Protection Area. This will over time cause serious compaction and be detrimental to the health of the trees.	Recommendation is to put some form of barrier to prevent cars from parking on the grass.	Advisory

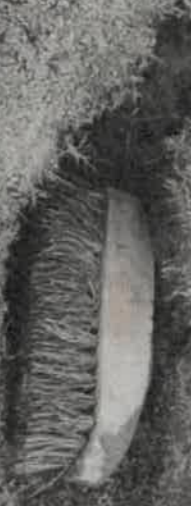
EXAMPLE OF
DAMAGE

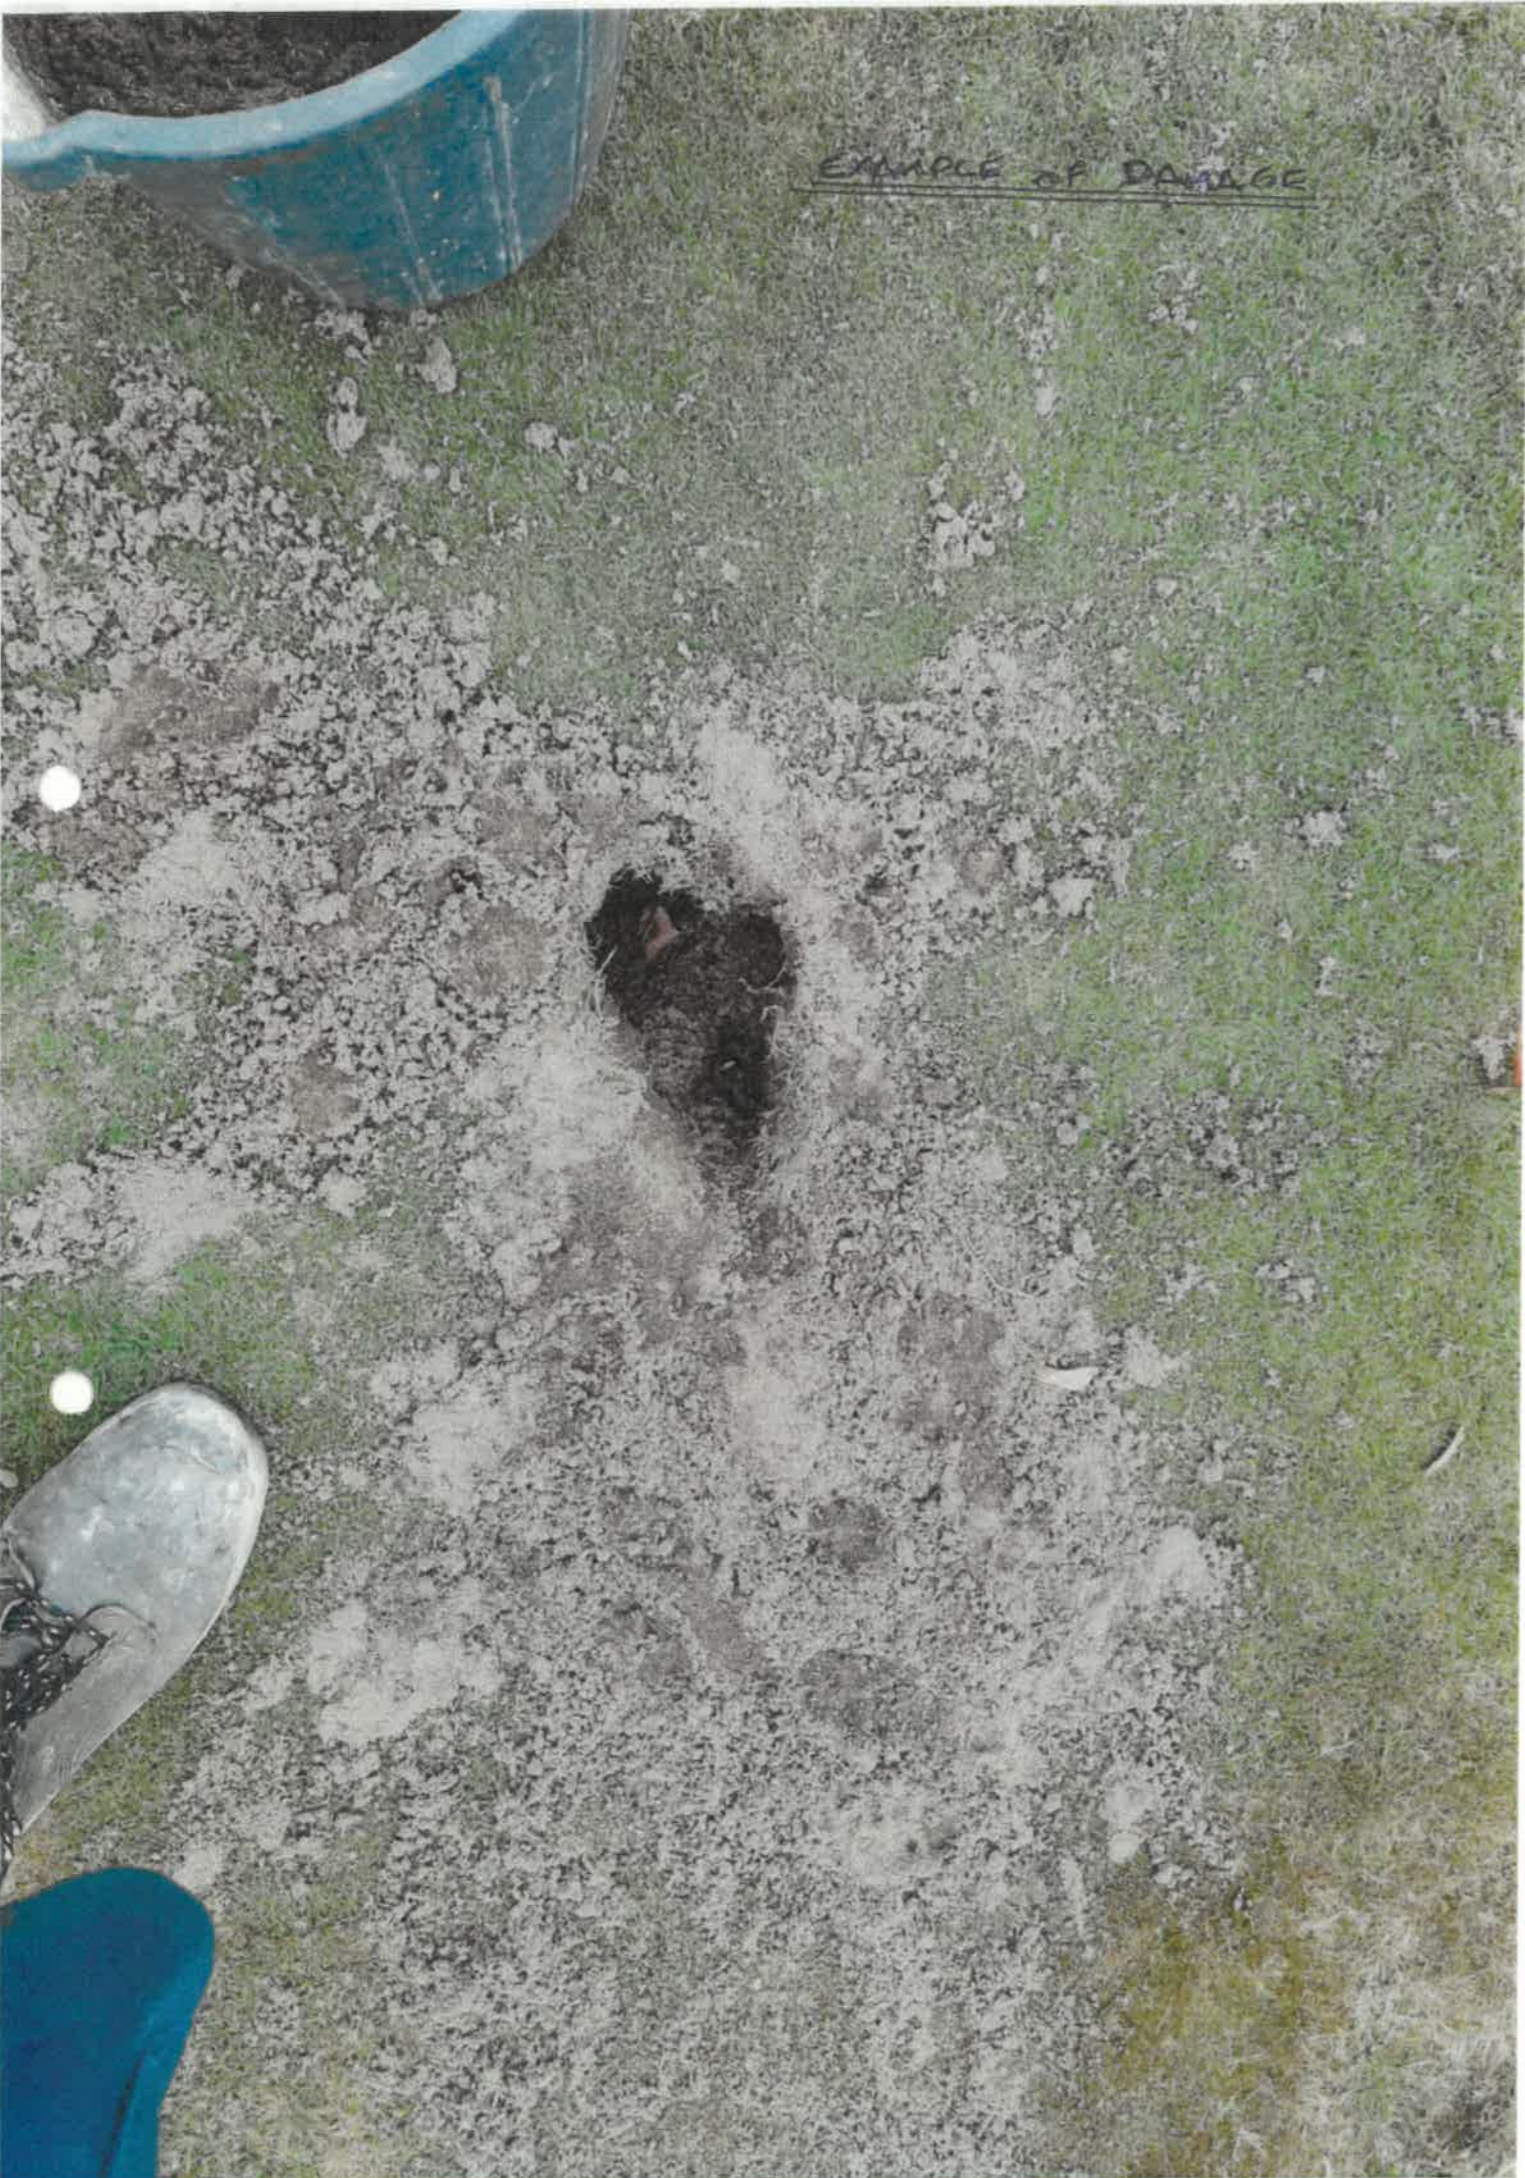
EXAMPLE OF DAMAGE
